Engineering a Safer, Cost-Effective Solution for Traffic Cone Refurbishment

Case Study

Traffic Cone Refurbishment

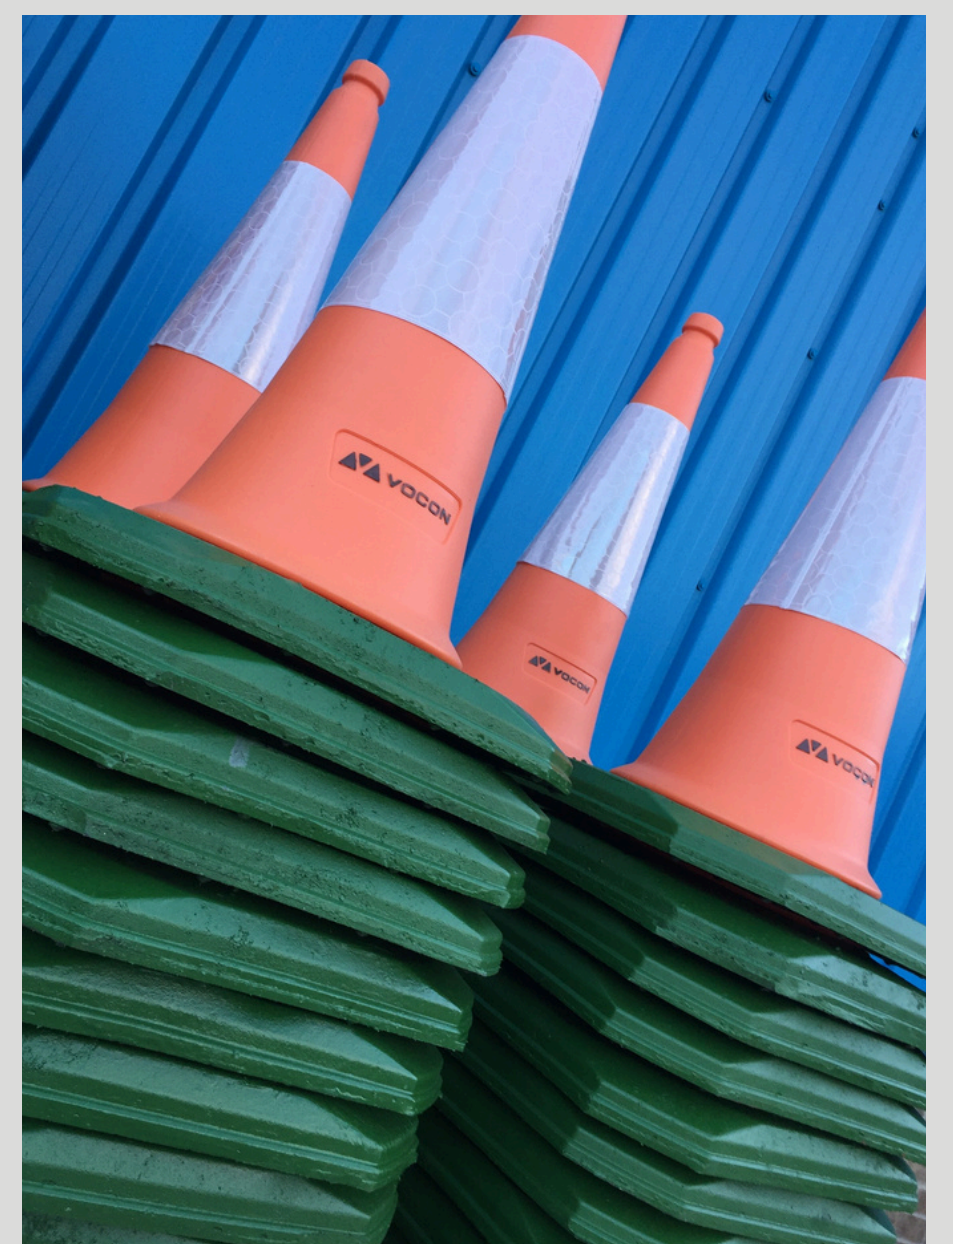
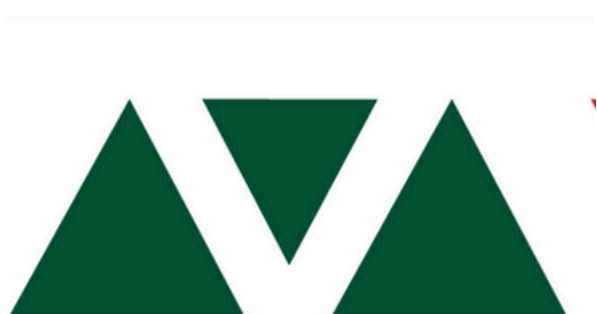
The heavy rubber bases were starting to detach from the cone bodies. Exposure to extreme weather conditions and damage from daily site activities can cause the cone and base to become disconnect from each other. Reattaching the two components manually can be dangerous due to how heavy the bases are. To reattach there is a 'lip' in the cone which must be pushed into the base with force.

A bespoke cone repair machine was designed and built in-house to securely fix detached bases back to their matching cone bodies.

VOCON developed a dedicated refurbishment programme focused specifically on restoring cones and bases. Each cone was inspected for cracks or other damage, with unrepairable units sent for recycling.

Once reattached, cones were deep-cleaned to remove dirt, tar, and paint, and fitted with new Class R2 or R1B reflective sleeves to restore full day and night-time visibility.

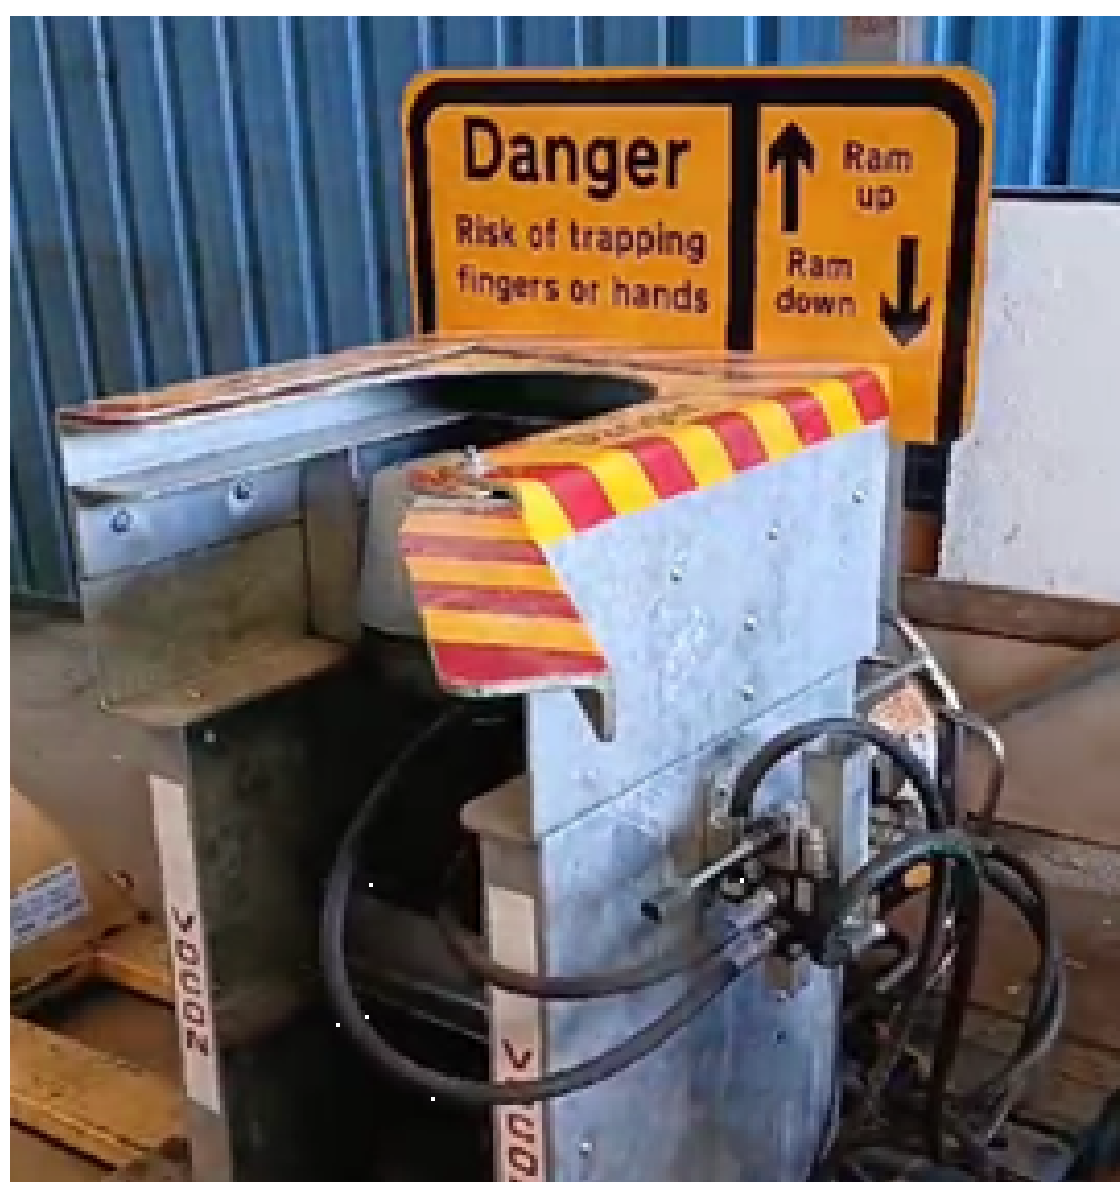
VOCON have restored over 2000 cones using this new bespoke machine between January - June. This has saved:

On average, we fix between 200–400 cones a day when the machine is in use between our Midlands & Yorkshire depots saving:
